**AMC<sup>®</sup> –**  
ML Coating for Mould Tubes

MELTING & CASTING  
TECHNOLOGIES

# AMC® - ML Coating for Mould Tubes

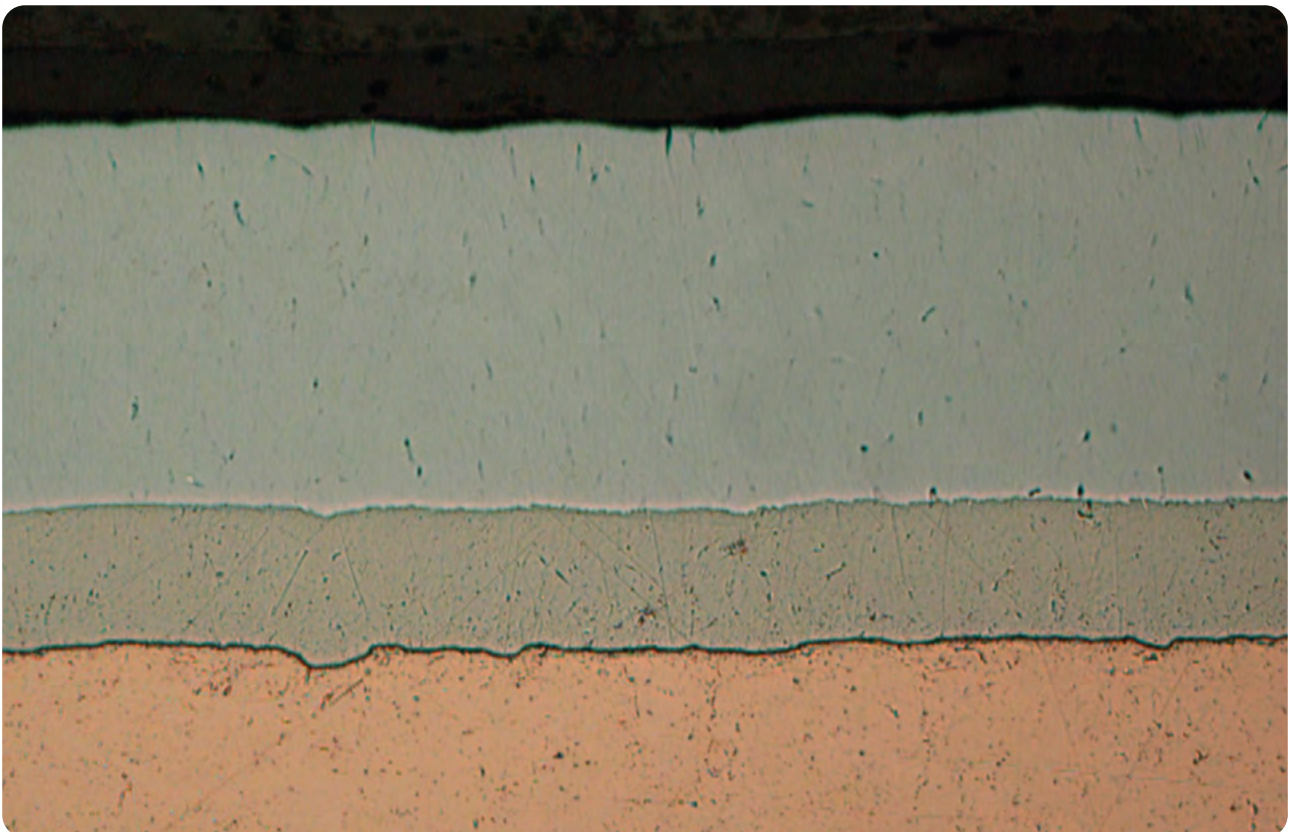
Sectional view of the AMC®-ML coating in the ingot mould tube

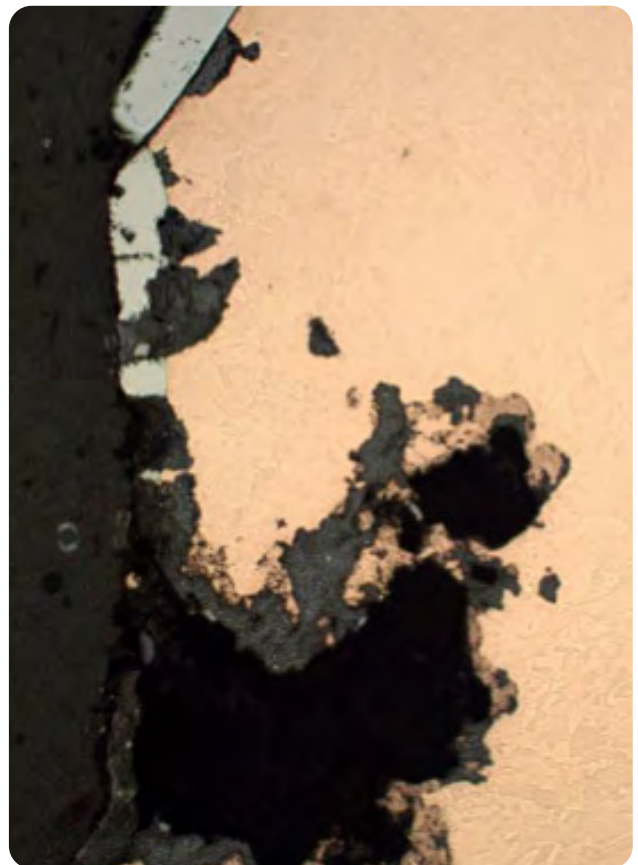
Black spots are sulphur corrosion

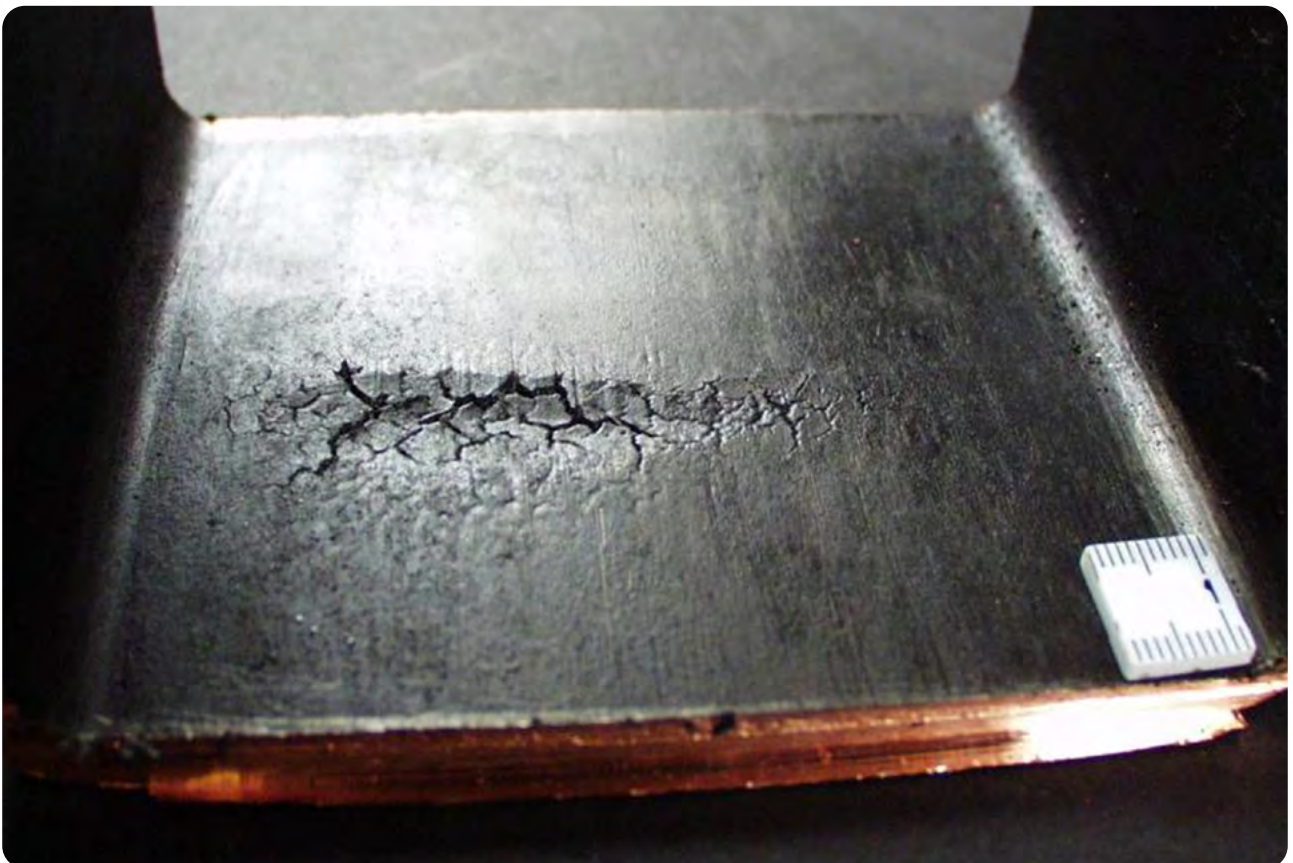
Sulphur corrosion

Sulphur coming to the copper will lead to chrome chipping at elevate temperatures (e.g.  $\geq 270\text{ }^{\circ}\text{C}$ ) by forming voluminous, brittle coppersulfides and development of cracks due to sulphur corrosion.
