CUNOVA

AMC[®] –
ML Coating for Mould Tubes

MELTING & CASTING
TECHNOLOGIES

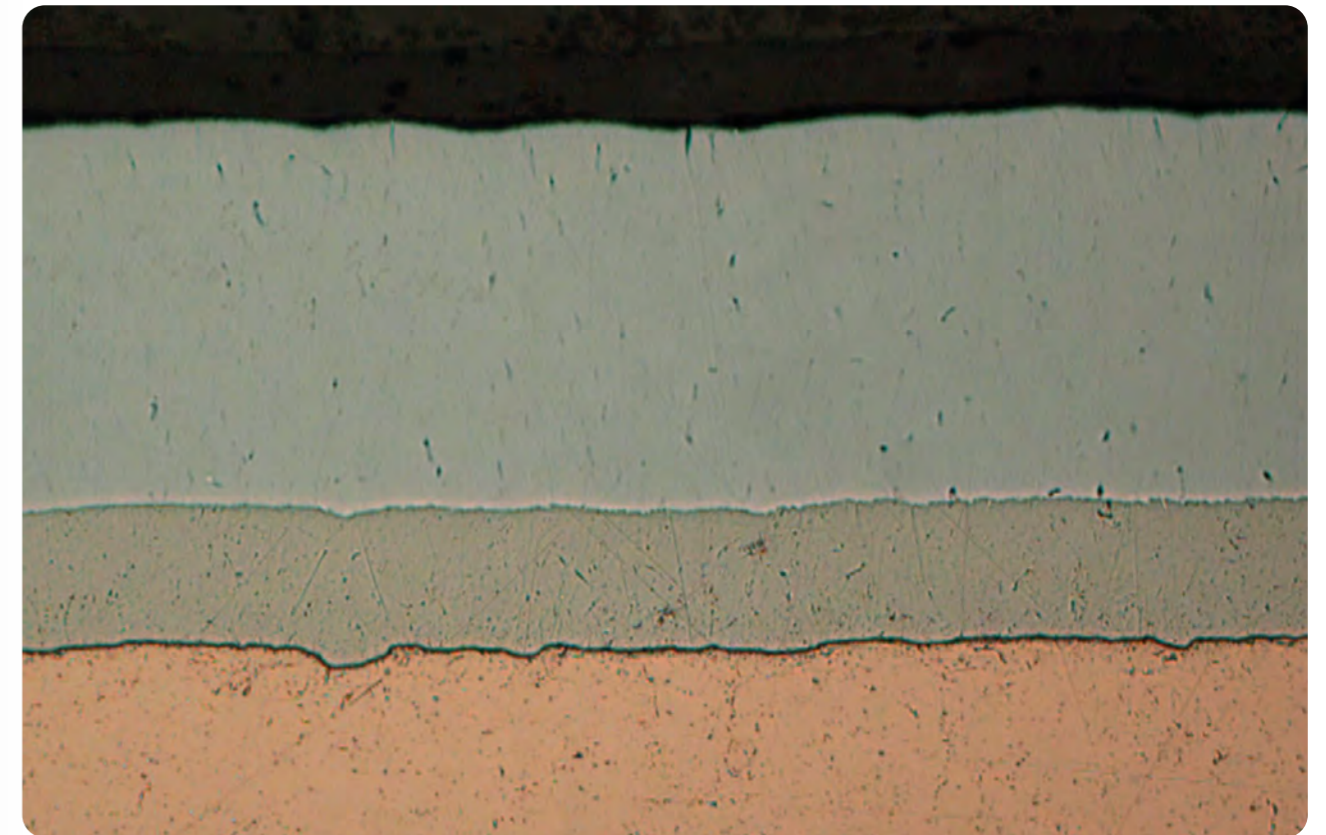
Sectional view of the AMC®-ML coating in the ingot mould tube

The tight flash of the intermediate layer is building a diffusion barrier between the micro cracking chrome layer and the Copper material we want to protect. It can be applied on all copper alloys and all types of mould tubes like billet, bloom and Beam Blank.

Due to this protection shield the penetration time for the diffusion takes much longer.

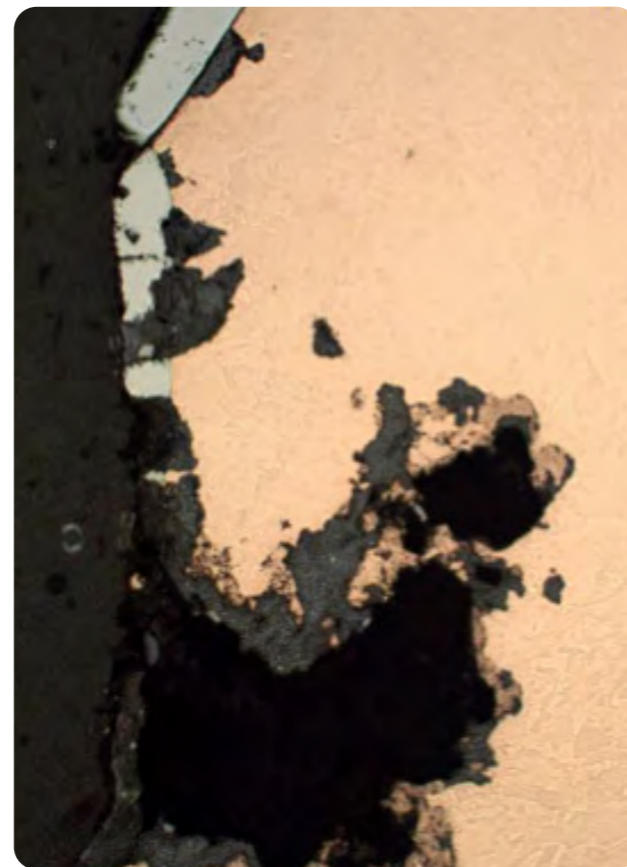
Black spots are sulphur corrosion

Sulphur coming to the copper will lead to chrome chipping at elevated temperatures (e.g. $\geq 270\text{ }^{\circ}\text{C}$) by forming voluminous, brittle coppersulfides and development of cracks due to sulphur corrosion.

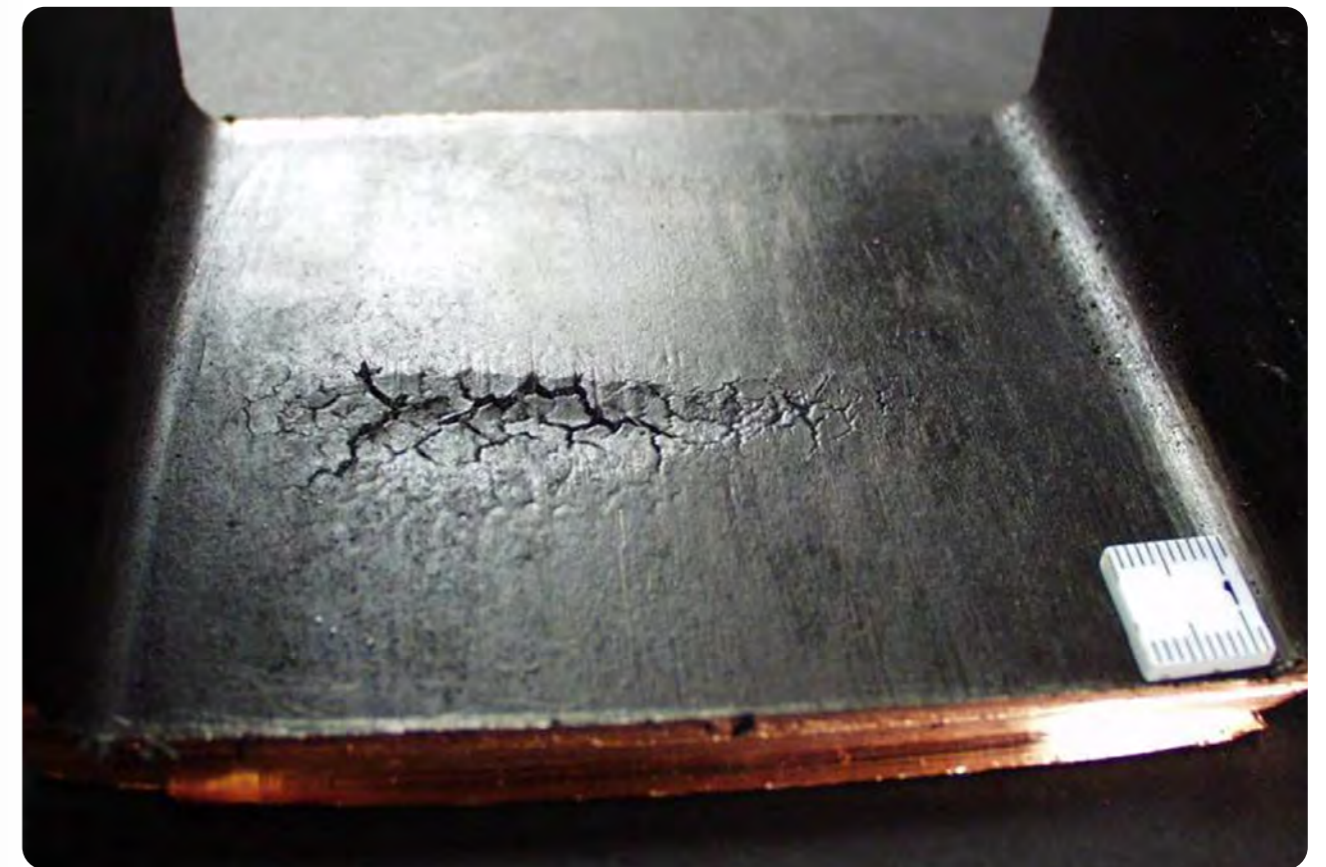
Sulphur corrosion

The source of the sulphur is mainly oil lubrication during casting. Most notably are here the mineral and synthetic casting oils. A possible other source can be the S content of the liquid steel, if for example “free cutting steel grades” are casted. These “free cutting steel grades” are high in S. The reason for the high S amount is that during CNC machining the chips are staying small and do not create long turnings and problems.
